ROMANIAN NAVAL AUTHORITY

PORT STATE CONTROL

M/V “GEO STAR” – IMO No. 7833107, flying TOGO flag, under Columbus American Register Class Society / Recognized Organization, called Constanta Port, Romania on 29th of January 2017 for loading 3000 to. corn in bulk.

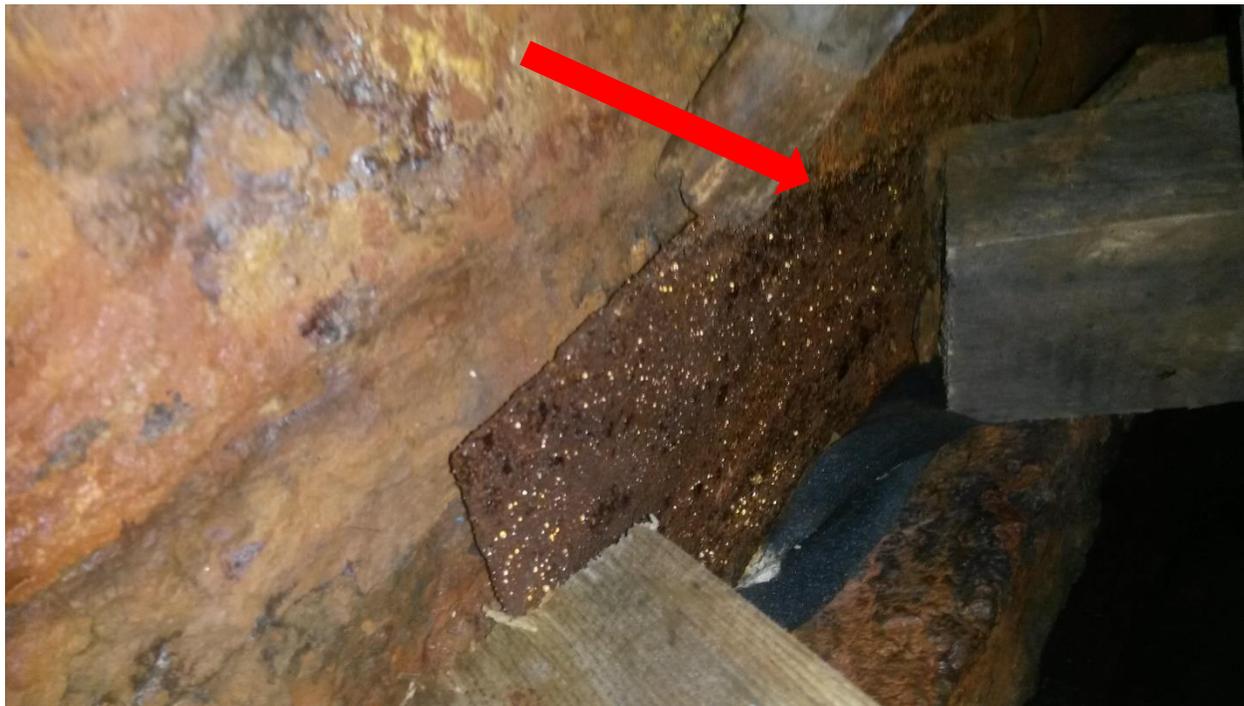
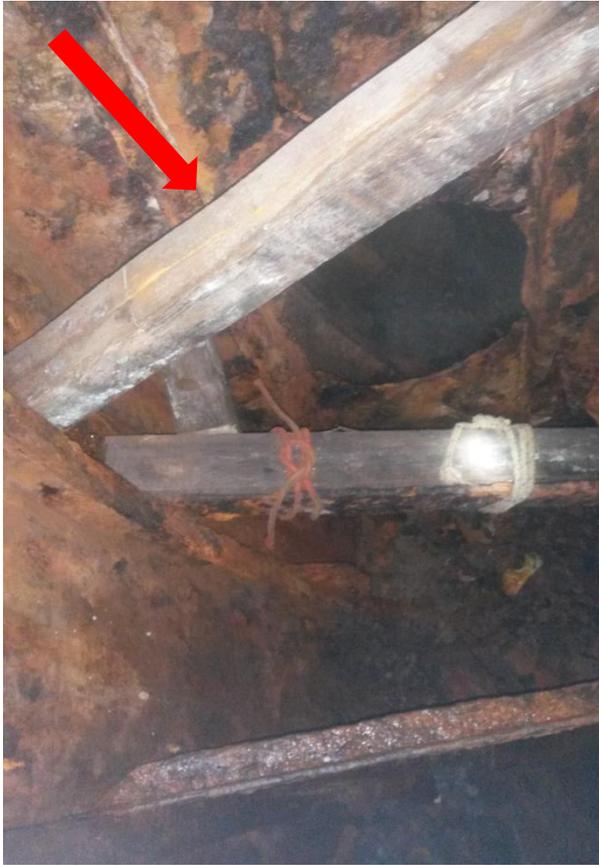
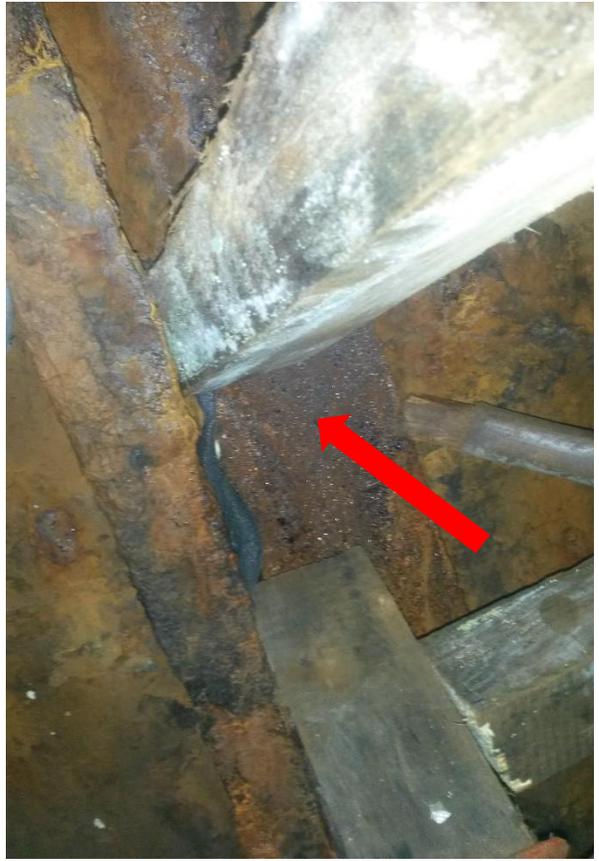
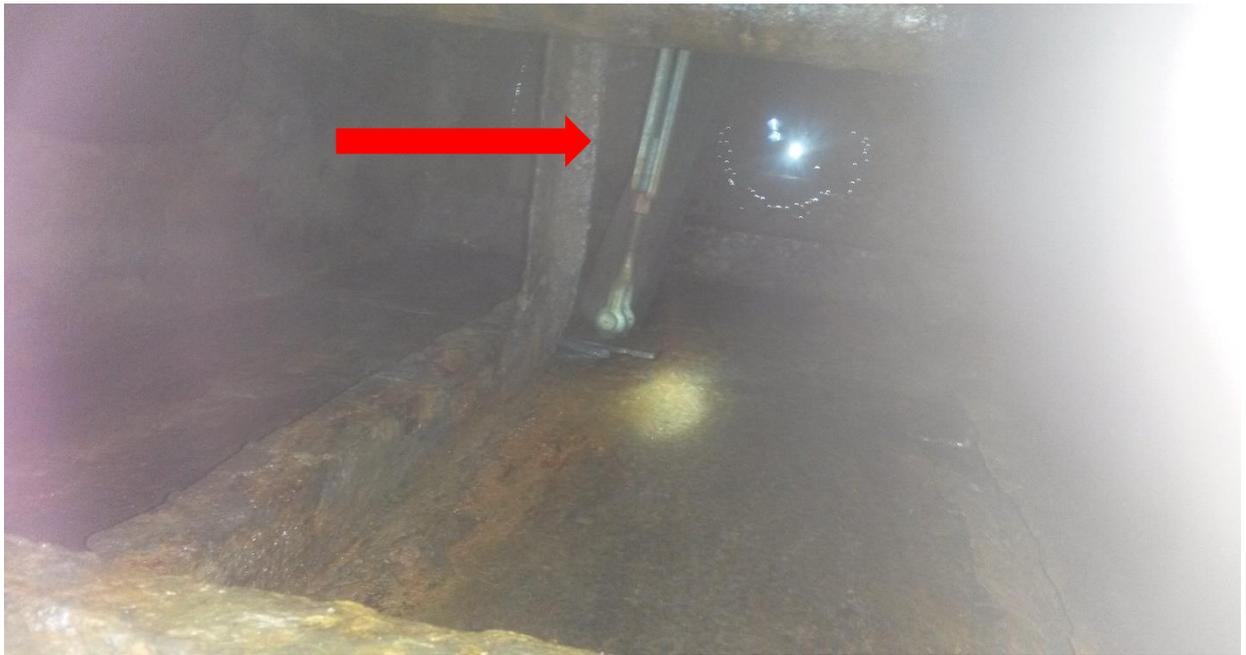
Ballast tanks no. 1, 3 and 5 heavily corroded and holed. Improvised “devices” for preventing water infiltration.

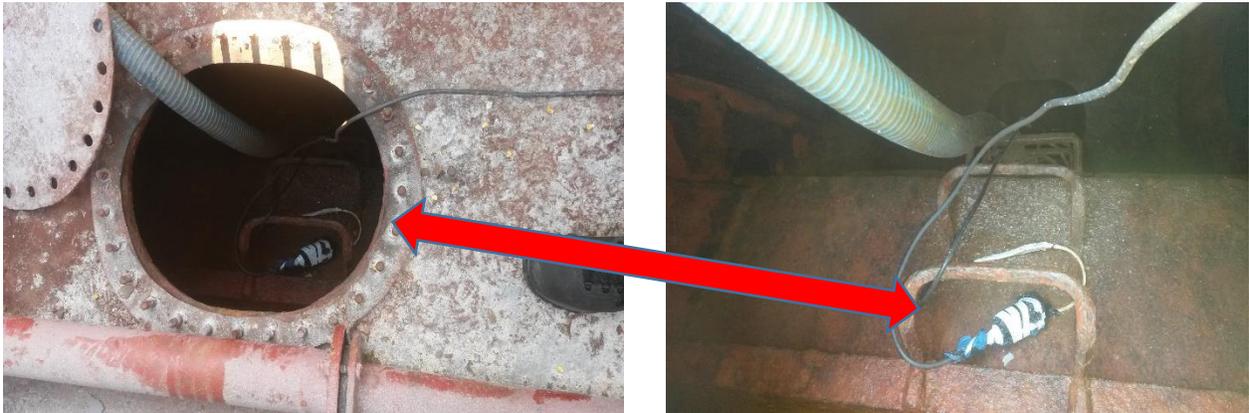
Ballast system out of order. Ballast water pumped out by submersible pump, unsafe electrical power supply.

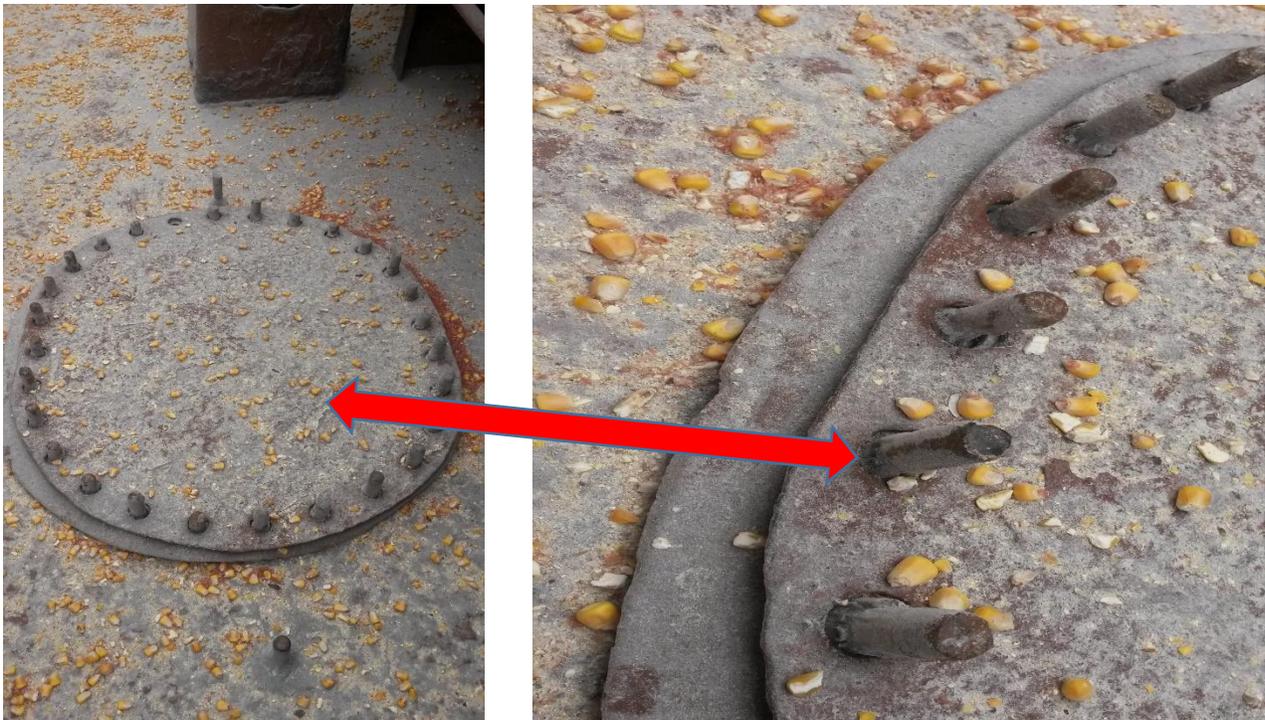
Ballast tanks manholes covers not tight due to bolts wastage.

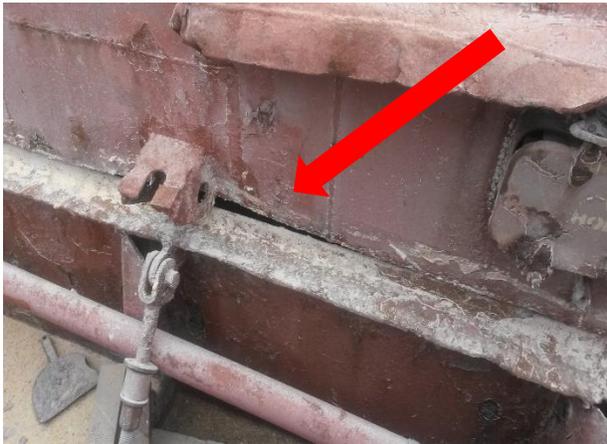
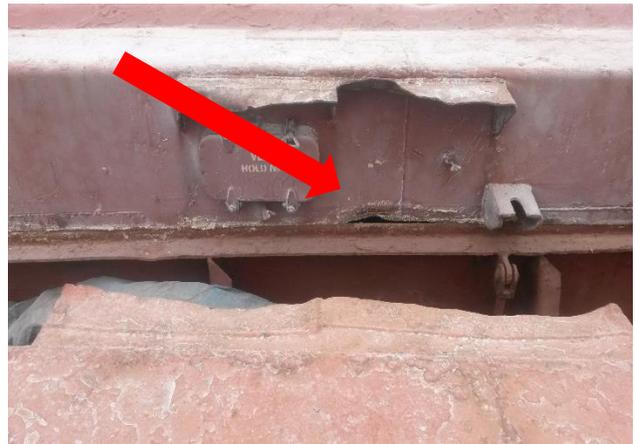
Hatch covers side edges bent in several areas.

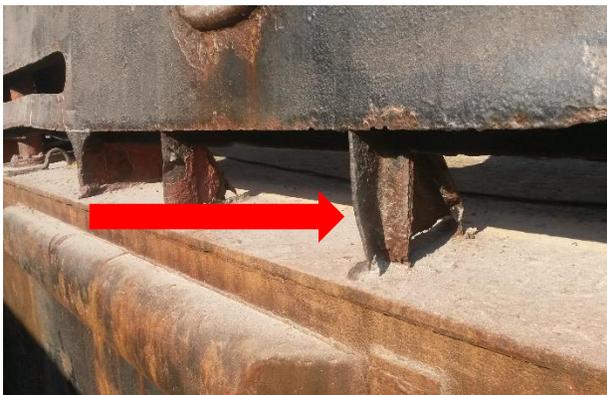
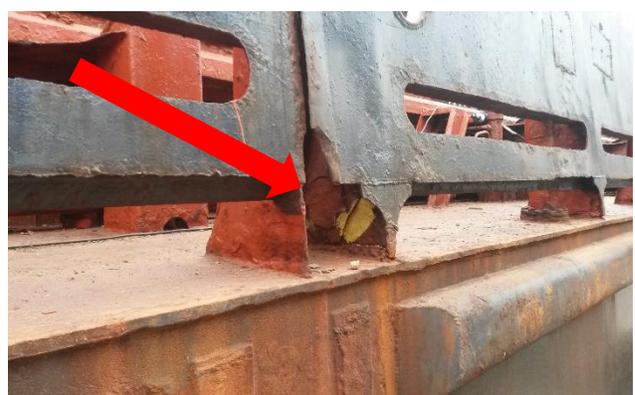
Bulwark stays cracked and wasted.

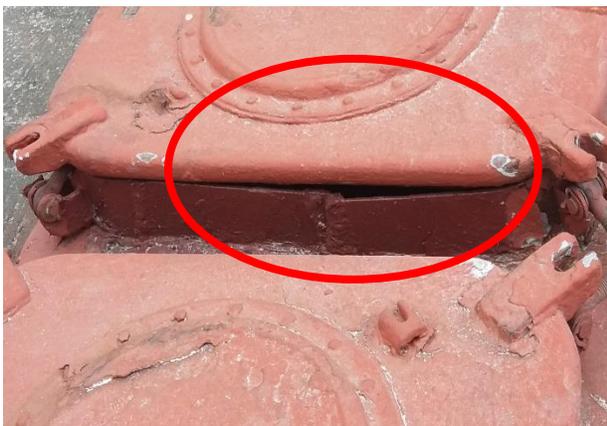
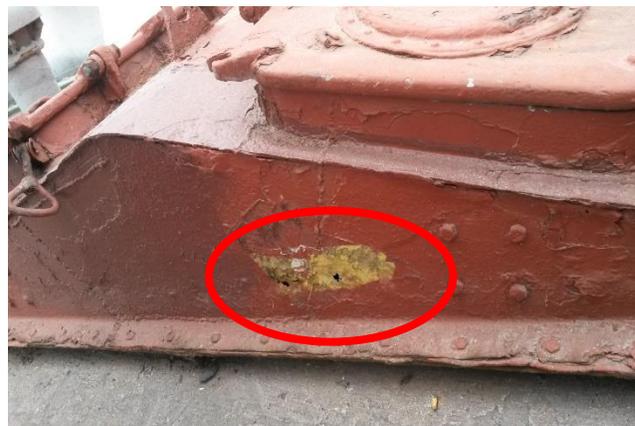
Engine room skylights frames bent and corroded through.

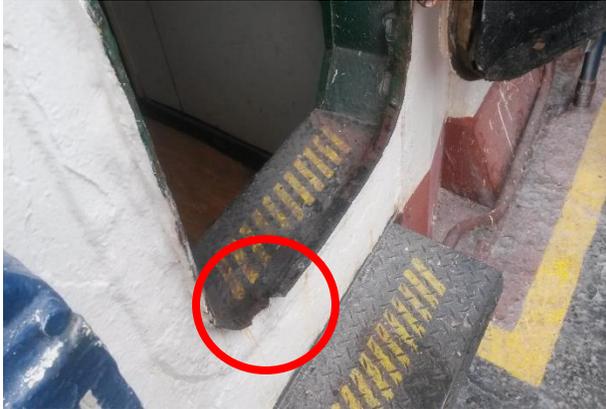
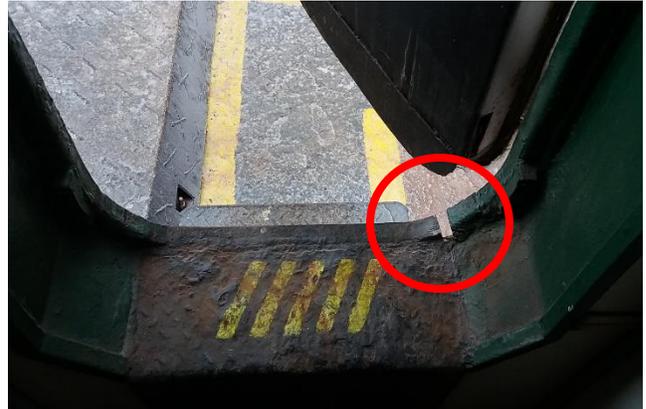
Main deck accommodation doors not watertight.

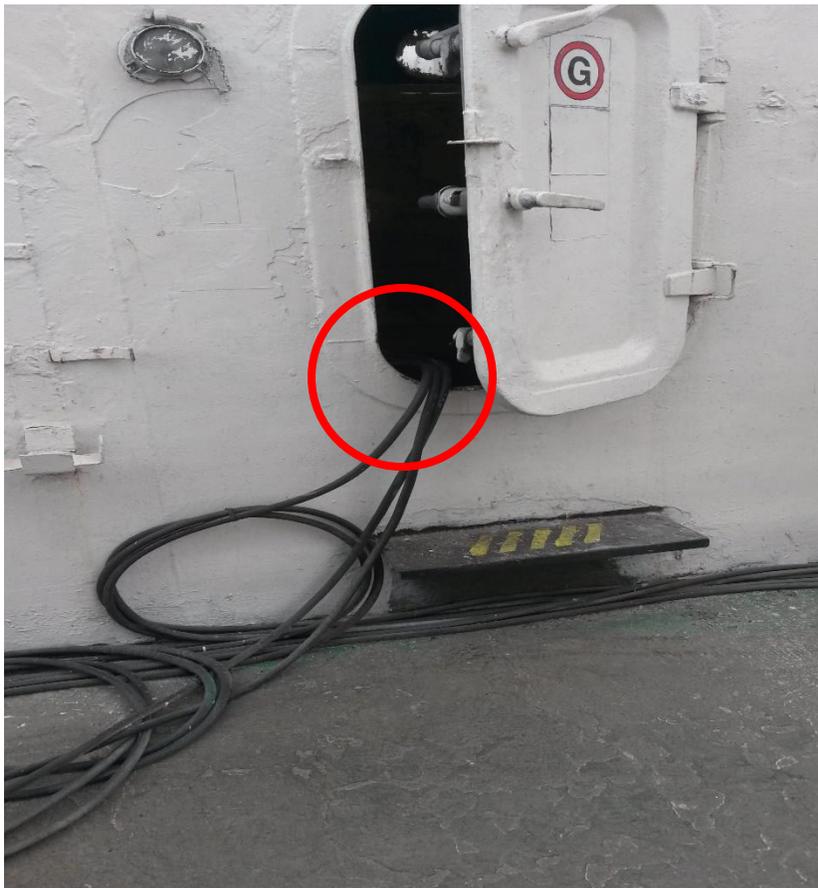
Improvised electrical cables crossing emergency generator room weathertight door.

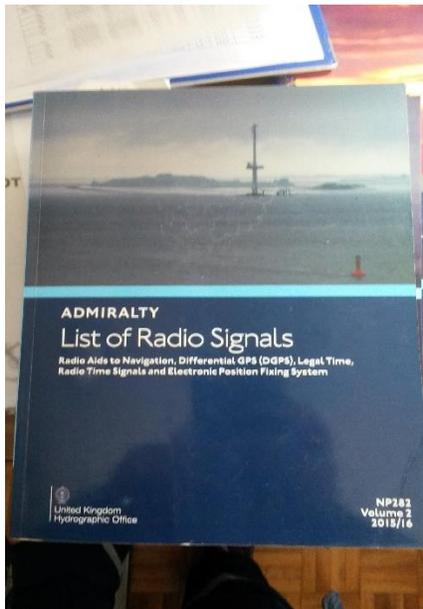
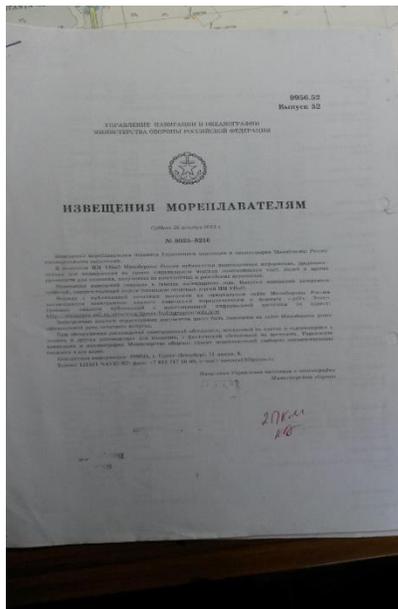
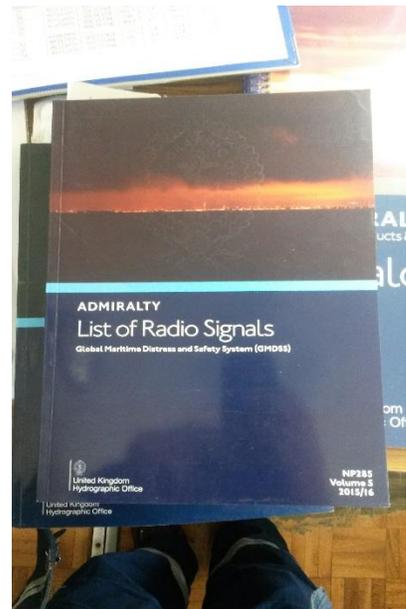
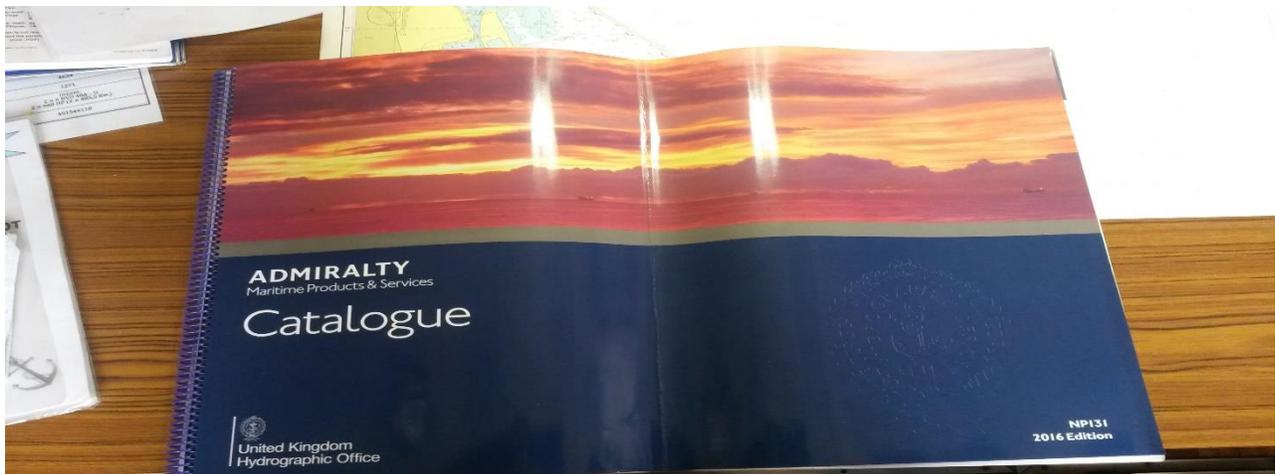
Most of required Nautical Publications expired.

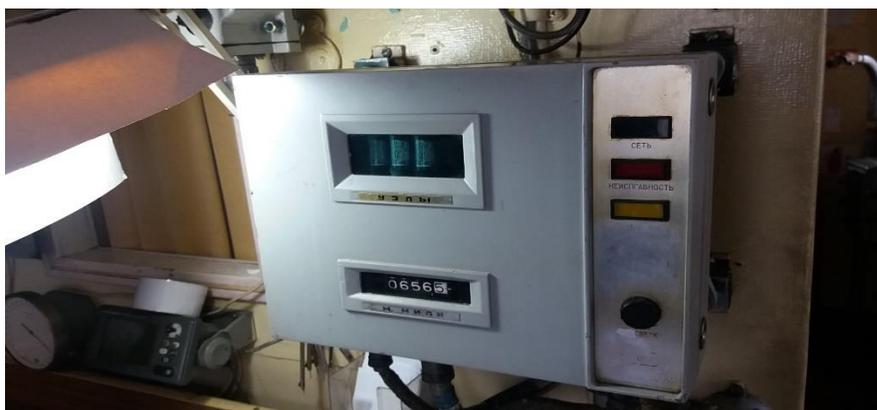
Speed and distance measuring device (through the water) inoperative.

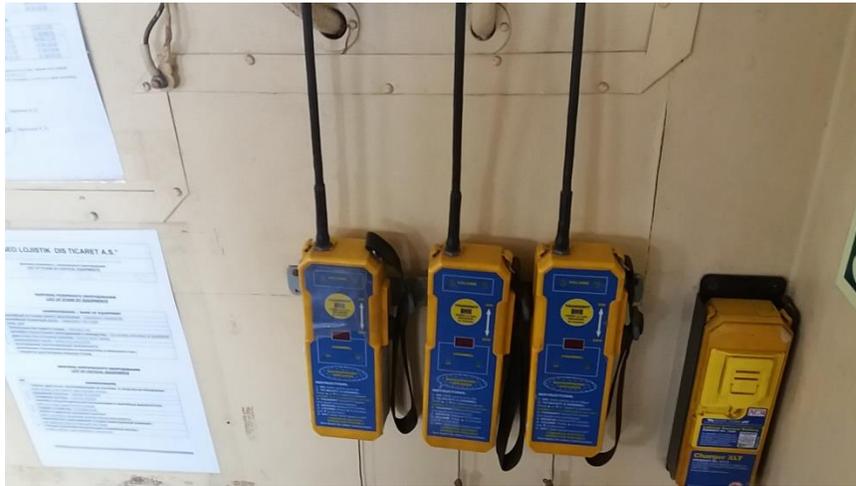
Emergency equipment for 2-way communication batteries missing.

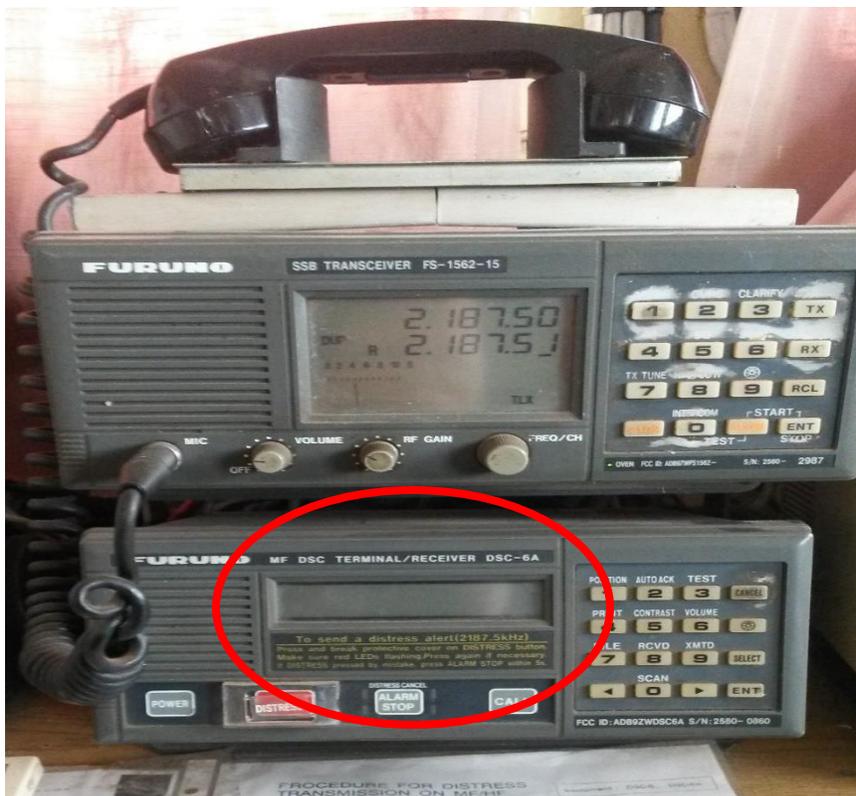
MF DSC and VHF DSC radio installations inoperative.

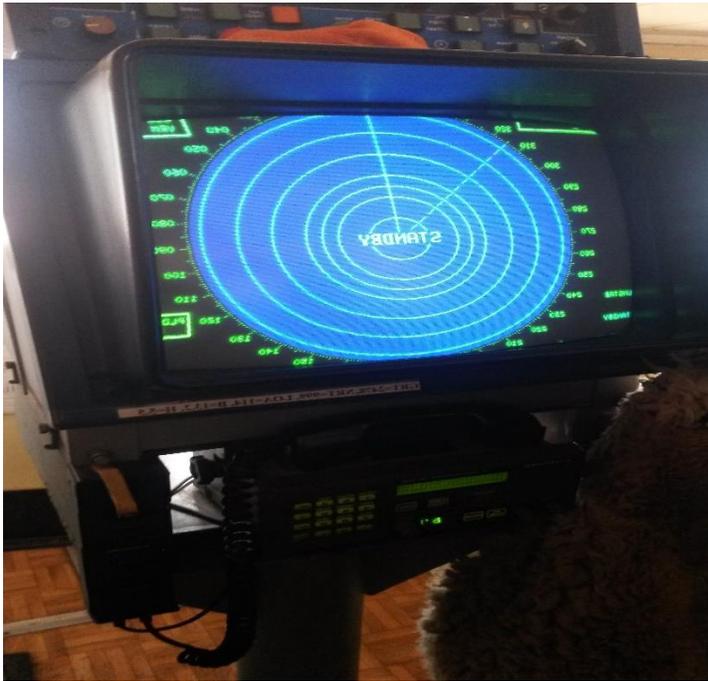
Second radar (in excess equipment) malfunction.

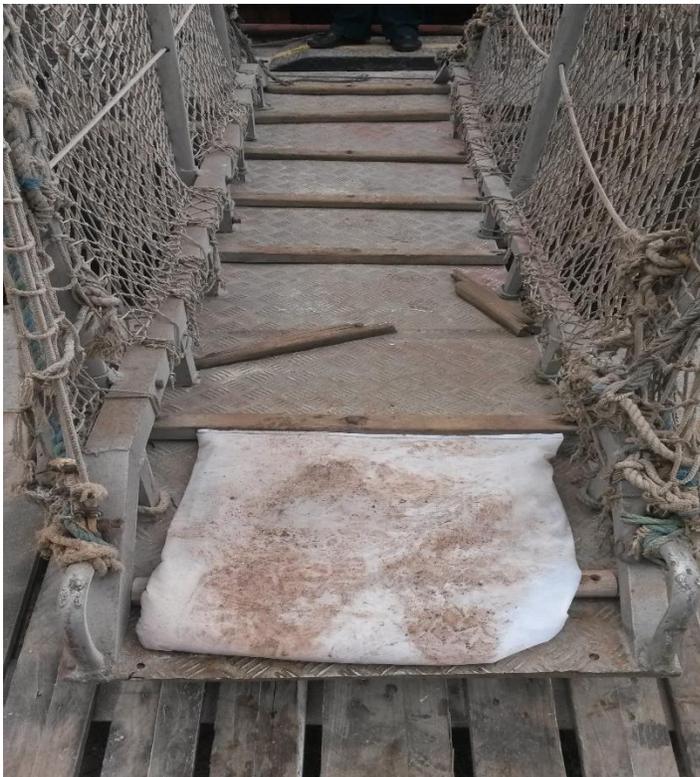
Morning time on 30th of January 2017 two PSC officers were nominated for inspection. Prior boarding, the PSC team proceed to an appropriate check of overall condition of the hull, Load Line mark and draft scales. Then they noticed that the access on board was unsafe due to several cracks of the gangway.

Shore-Ship access gangway cracked in several points.

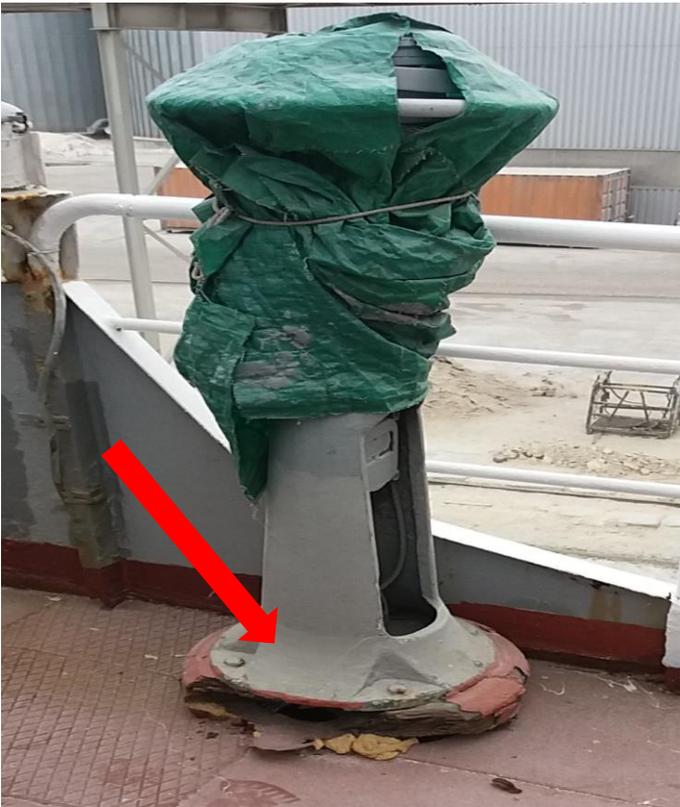
Port/Starboard gyro repeaters foundation heavily corroded.

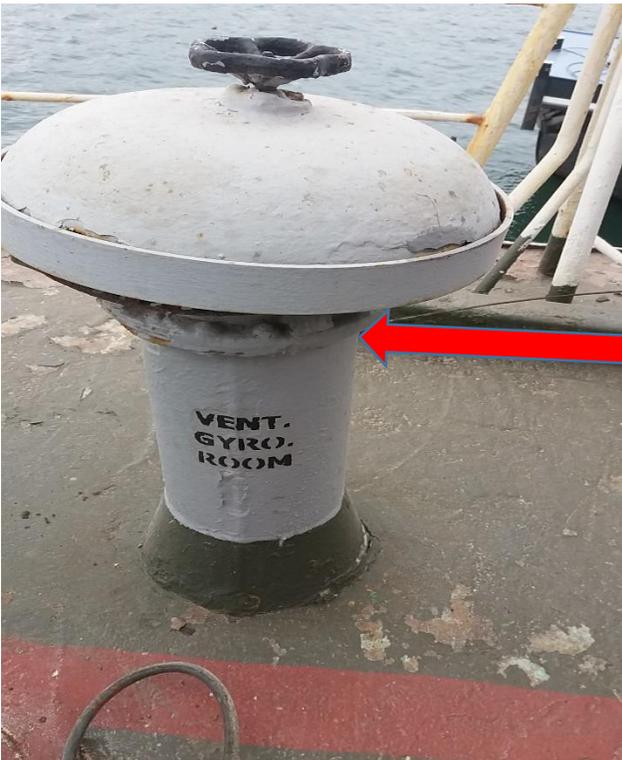
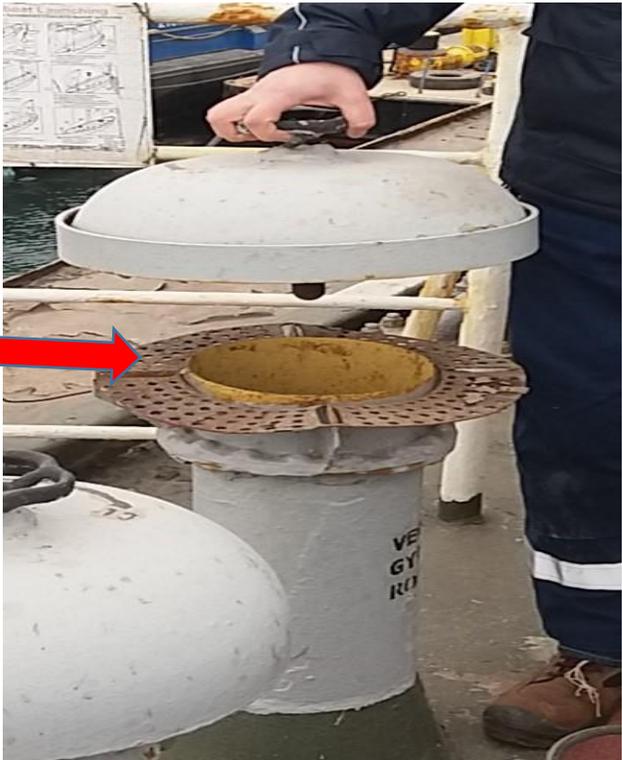
Gyro room ventilation mushroom damaged.

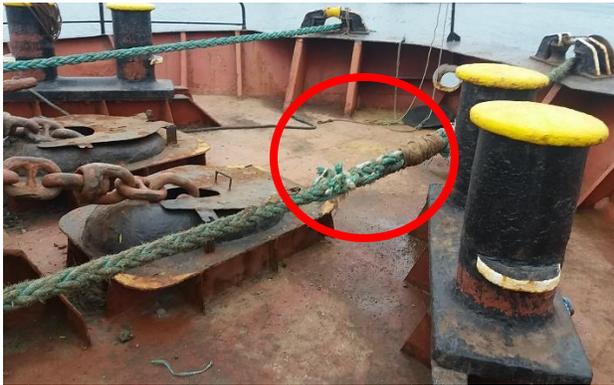
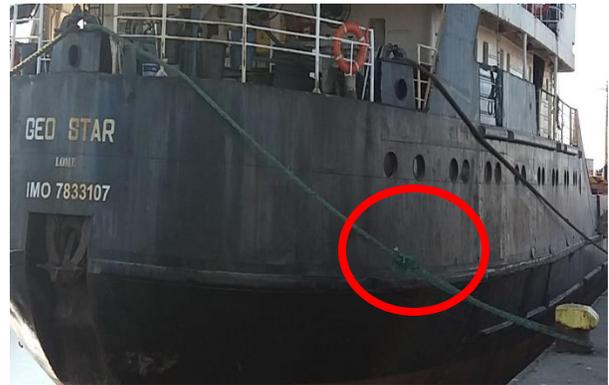
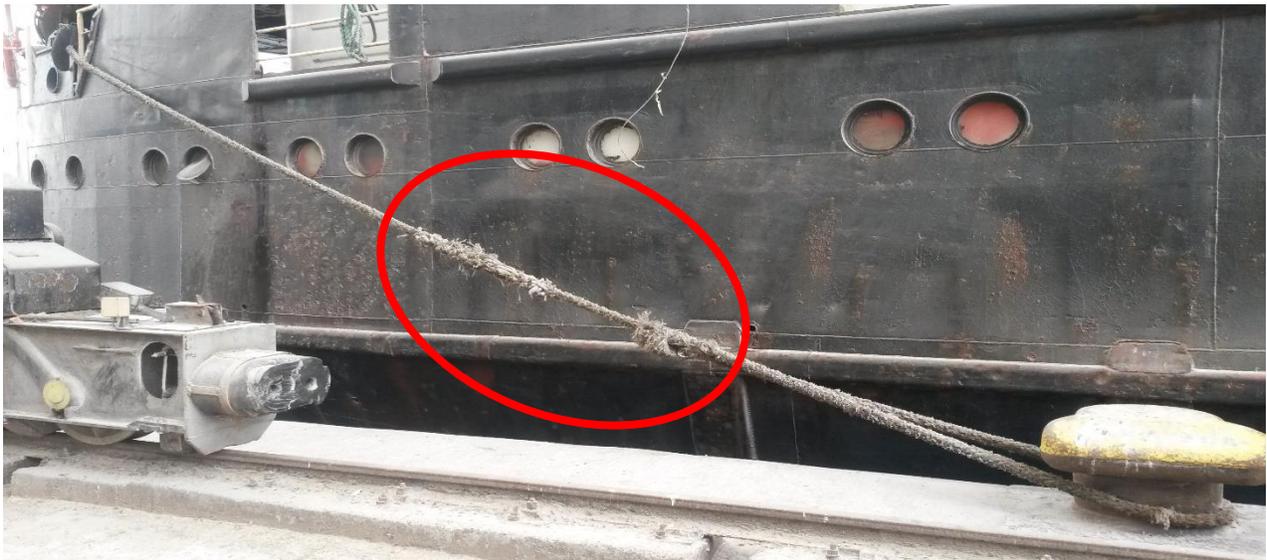
Mooring ropes damaged.

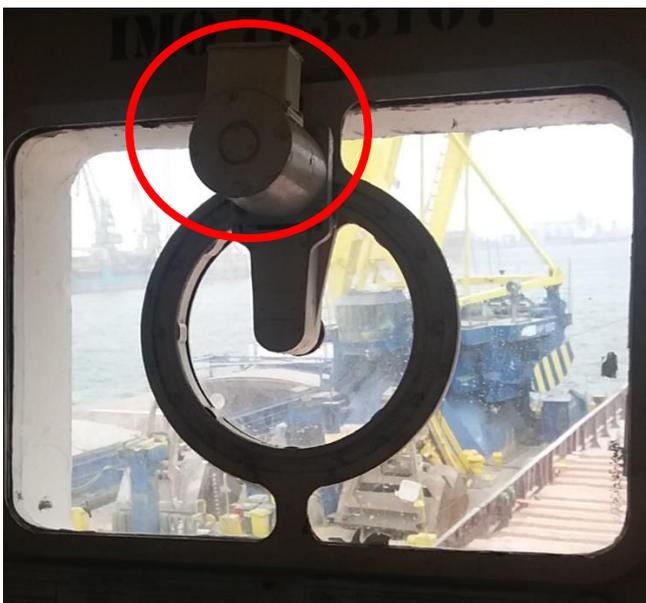
Clear view screen window inoperative.

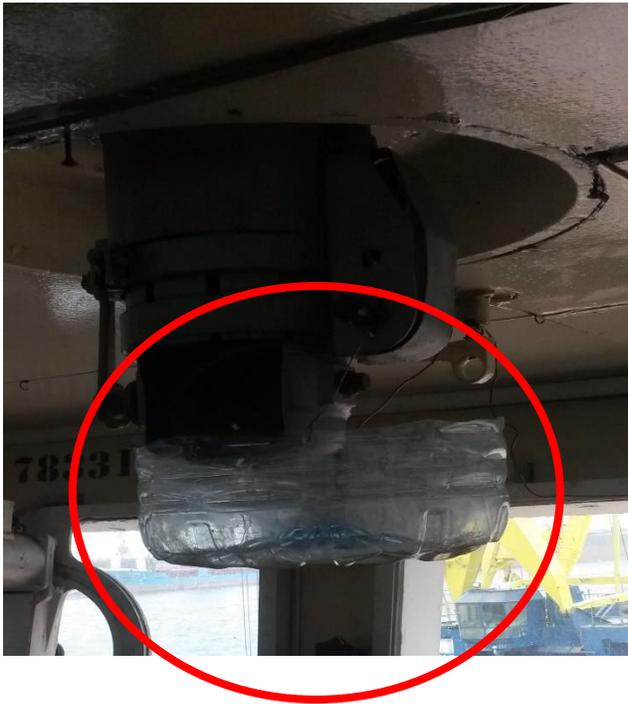
Magnetic compass water ingress.

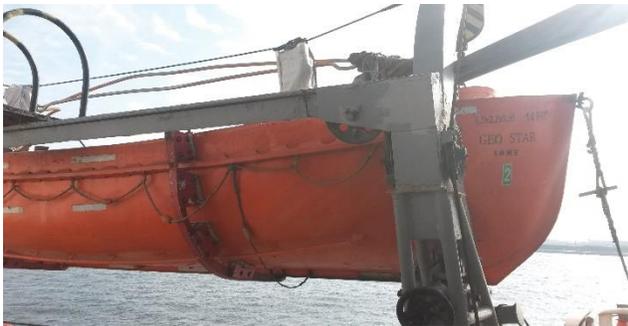
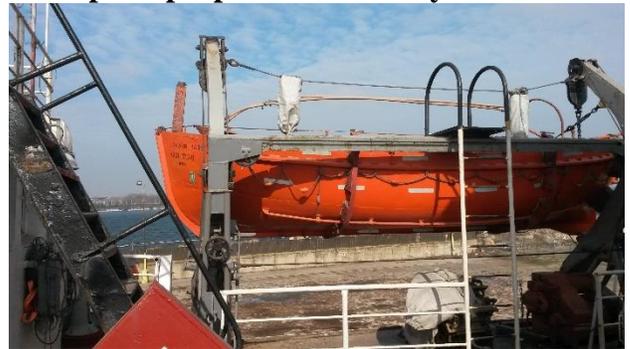
Port side lifeboat motor inoperative; Stbd. side lifeboat pitch propeller and trolley stuck.

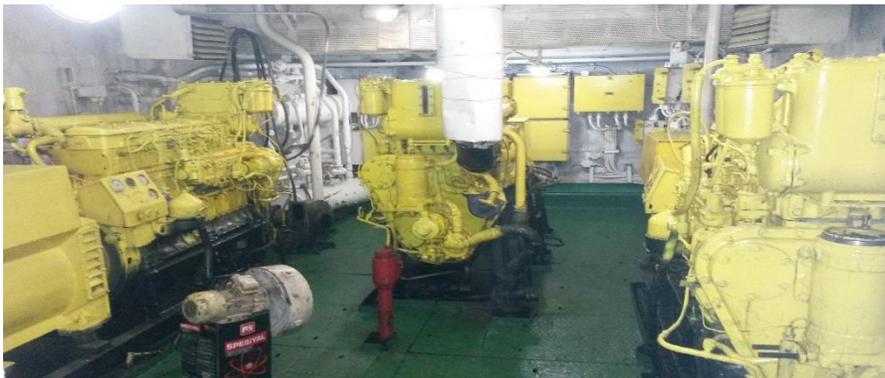
Two diesel generators out of order (electric generators damaged).

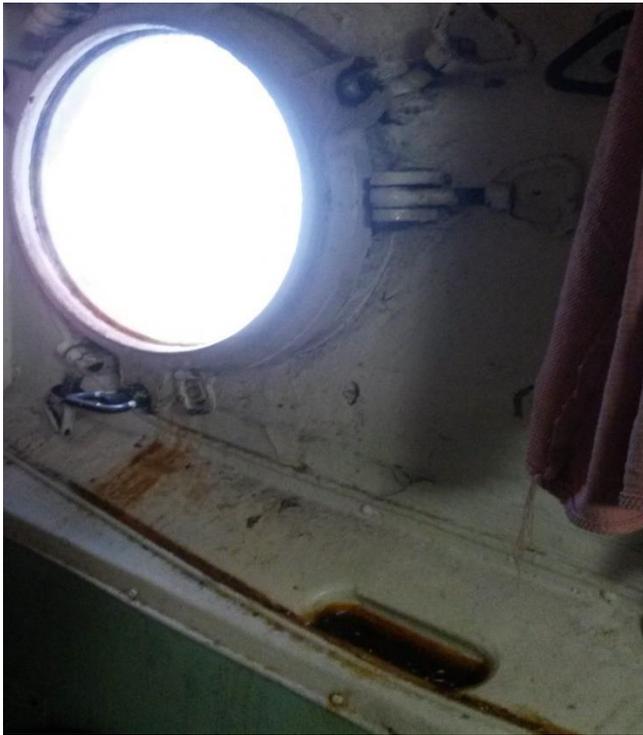
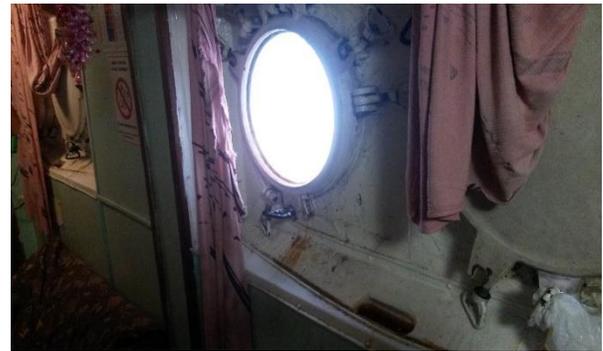
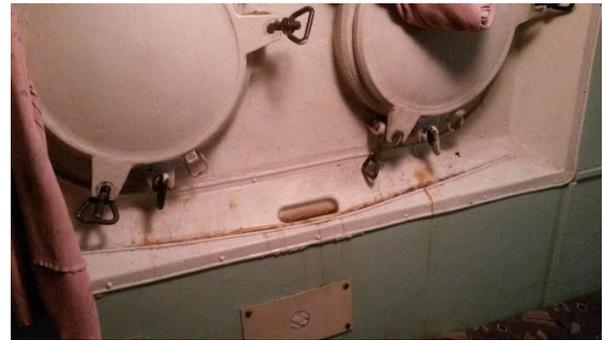
Officer's mess-room side scuttles not watertight.
