Name	NORTH STAR
- Name	1101111101711
IMO	7811410
Flag	MOLDOVA
Туре	GENERAL CARGO
GT	1707
Class	BRS
RO	BRS
Imo Company	5847153
Date Keel laid	15.08.1978

The GENERAL CARGO "NORTH STAR", IMO N° 7811410, flying Moldova Flag, sailing from TENES (ALGERY), arrived in Marina di Carrara Harbour on 17<sup>th</sup> May 2017 for cargo operations (marble blocks), with Priority 1 and subject to Expanded Inspection.

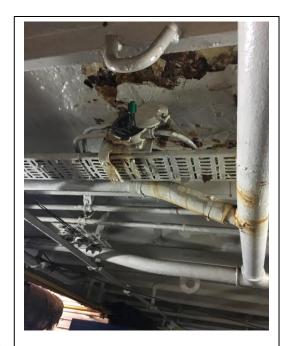
Picture 1: Ceiling Bulkhead cracked

At the second deck, just under the main deck, the ceiling bulkheads of the room leading to the steering room was cracked with evident signs of corrosion and water penetration from the upper deck; most of the lights were found inoperative, including all the emergency lights. Port State Control inspectors discovered that, due to a serious failure, the electric system was inoperative, as well the emergency generator and the emergency fire pump!

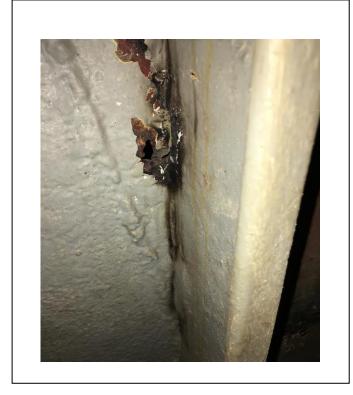
Moreover it was discovered that sea water inside the tank was mixed with oil, probably hydraulic oil penetrated into the tank from the manhole, due to leakages from steering gear pumps (see Picture n. 6).

Picture n. 6: Oil in WBT (Aft Peak Tank)
