HELLENIC REPUBLIC
MINISTRY OF MARITIME AFFAIRS AND INSULAR POLICY
HELLENIC COAST GUARD

DETENTION OF M/V "ARFETISALLE"
FLAG: DEMOCRATIC REPUBLIC OF CONGO
IMO: 850903

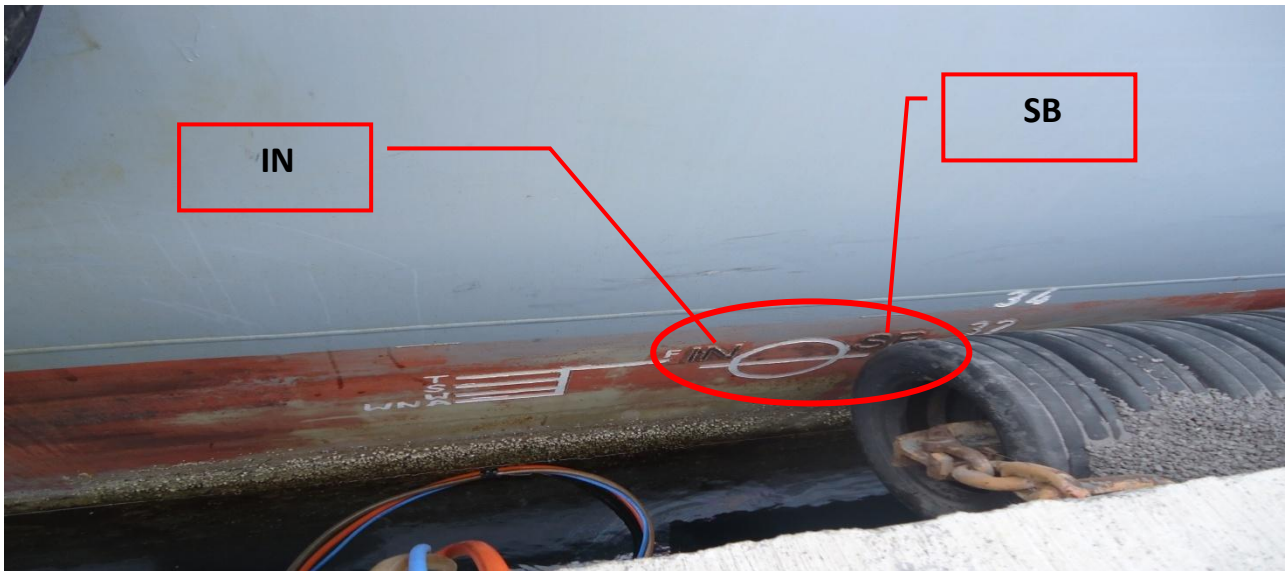
- 1. The Mark of the Assigning Authority was not in accordance with the relevant ICLL certificate (**INSB** instead of **BR** / **BRS**). (See picture at next page)

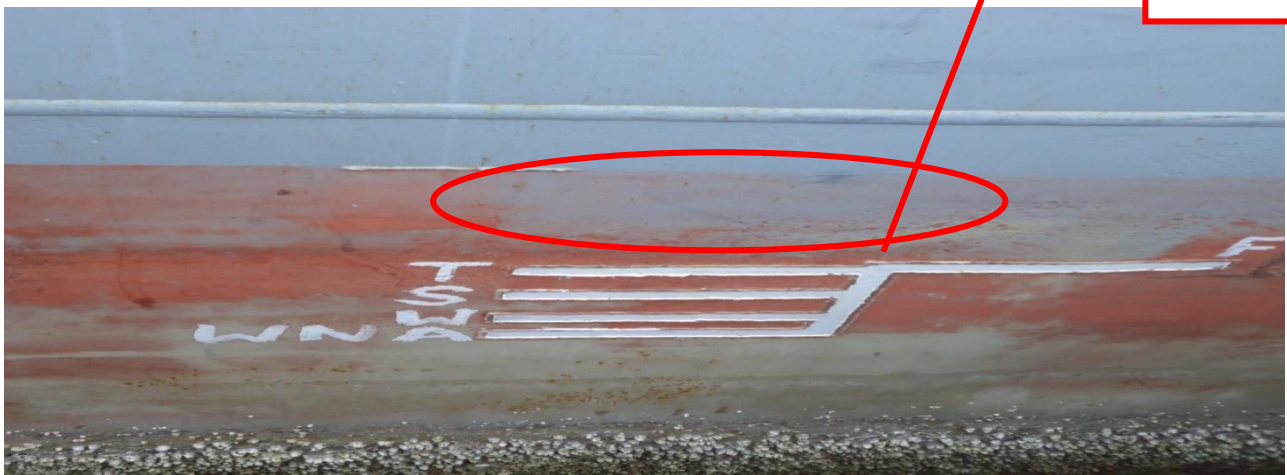
2. Tropical Fresh load line (TF), according ICLL certificate , was missing.

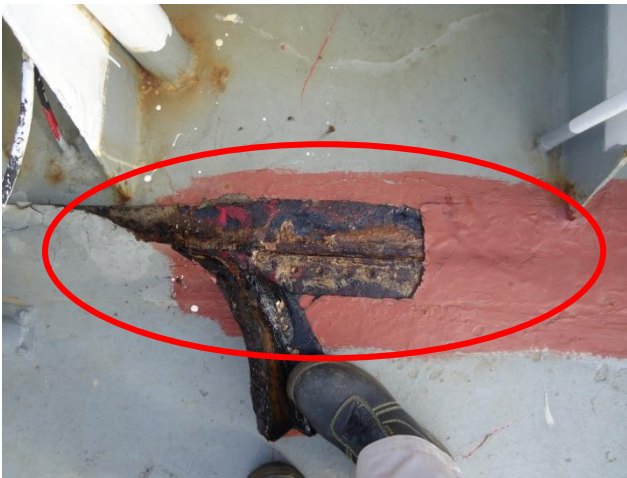
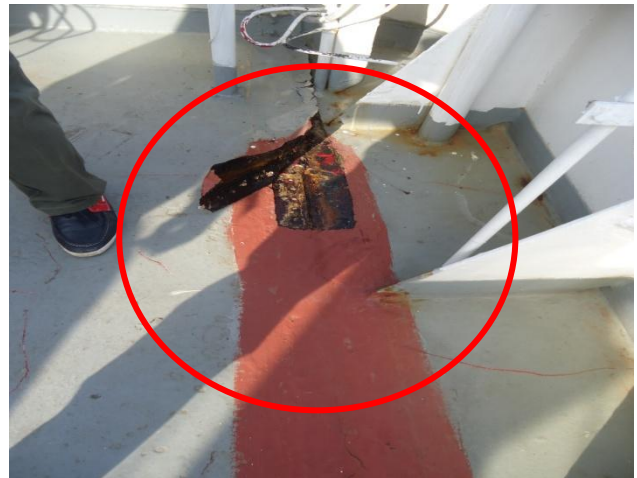
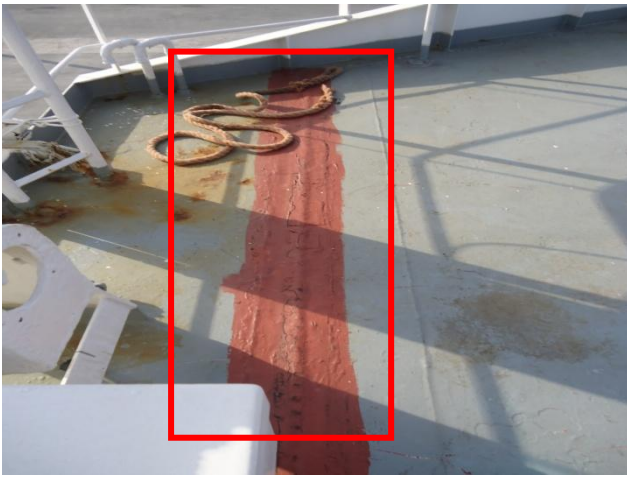
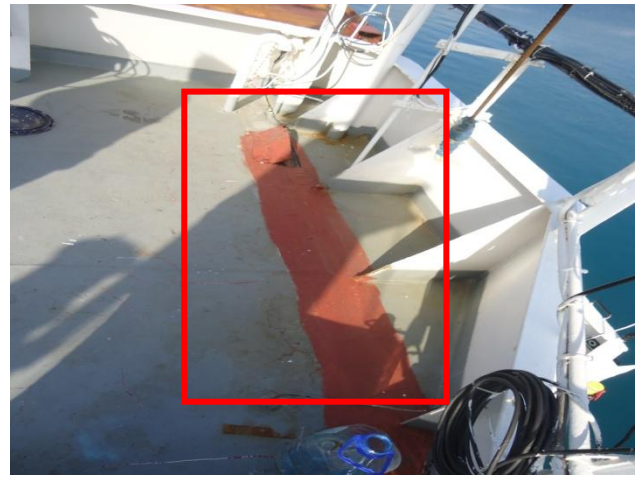
3. The connection between deck plates on the monkey deck was covered by rubber (tape).

The PSCO, in order the ship's weather tightness to be verified, required an attestation by the R.O. The deficiency was noted as clear ground for detention.

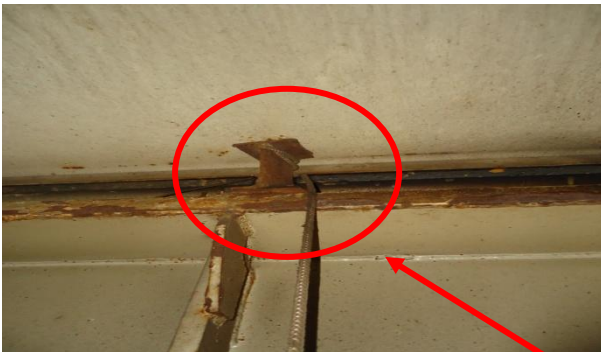
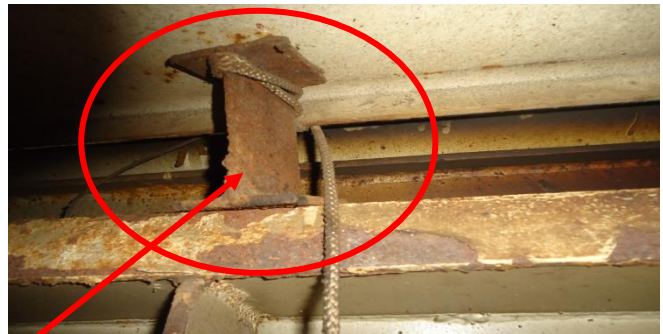
4. The closing mechanism of the Fire Dampers located at the funnel was found inoperative.

A piece of metal was placed in order to keep the damper open and a rope was fasten on it.

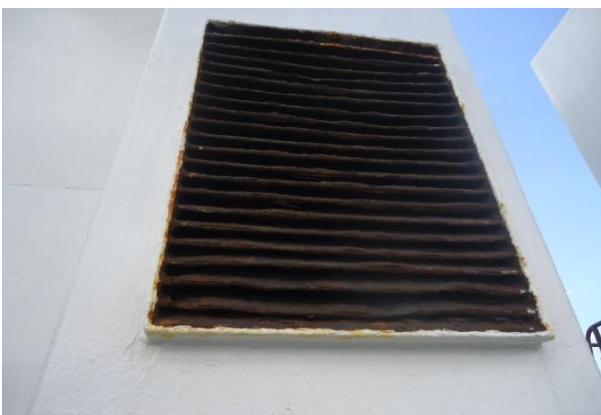
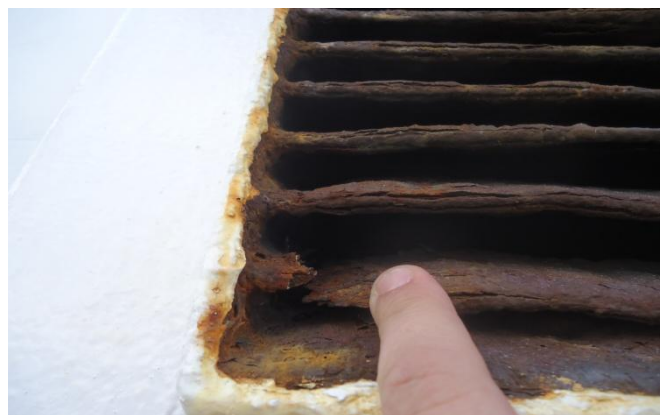
6. Grilles of STBD side D/G ventilator were found corroded.

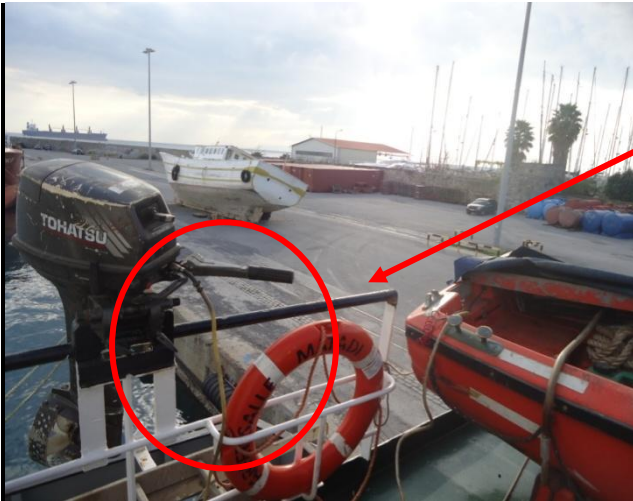
1. The gas oil pipe line which was connecting the reservoir of the rescue boat, with the engine was inappropriate (plastic pipe line used for water). During the engine test it was leaking.

Plastic pipe line usually used for water which was leaking during test.

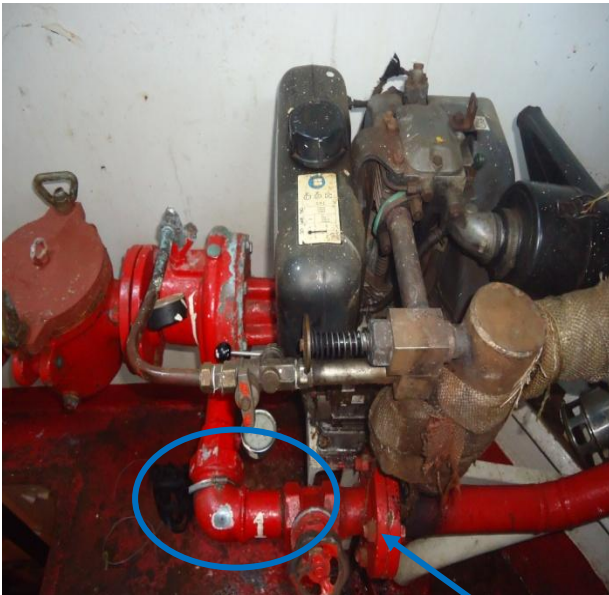
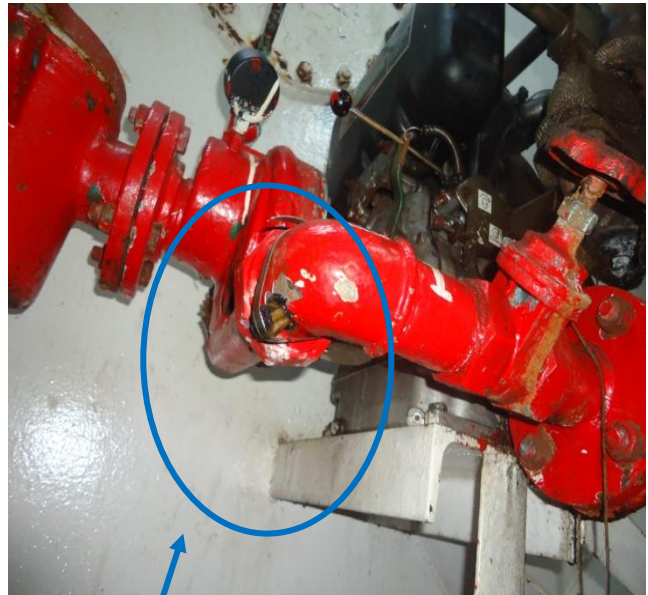
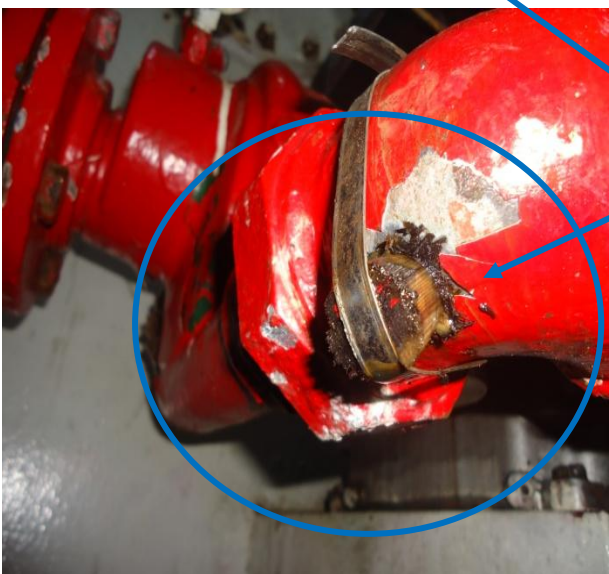
3. The Emergency Fire Pump couldn't deliver sea water during test. Also the delivering pipe line was found leaking from a hole which was "repaired" temporary by a wooden plug. The deficiency was noted as a clear ground for detention.

A hole "repaired" by a wooden plug.

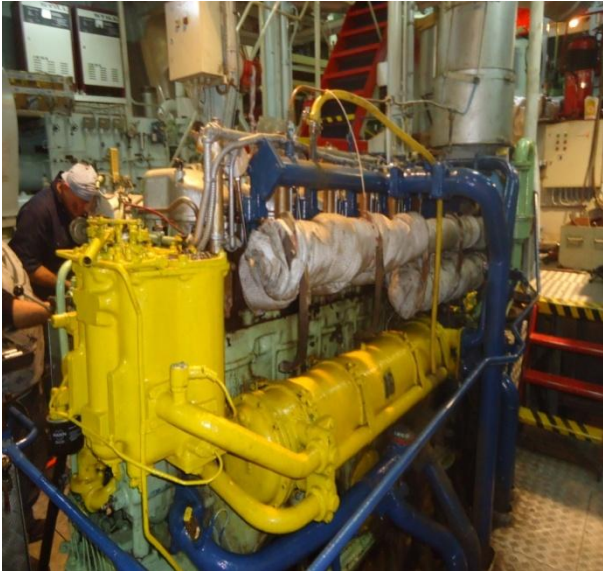
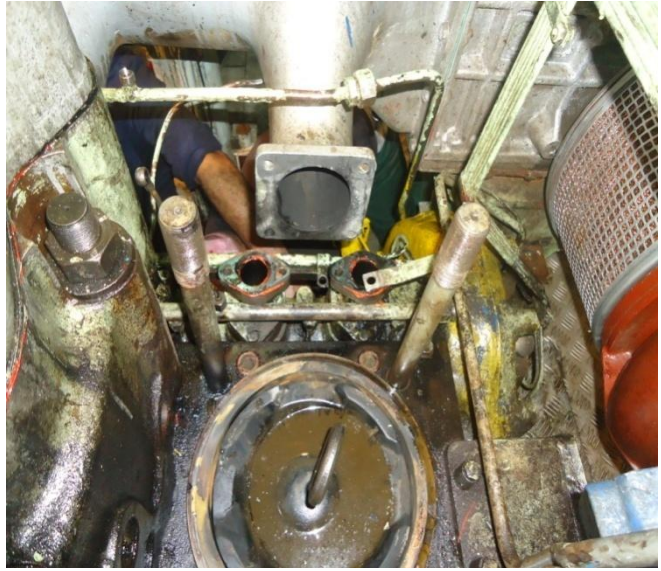
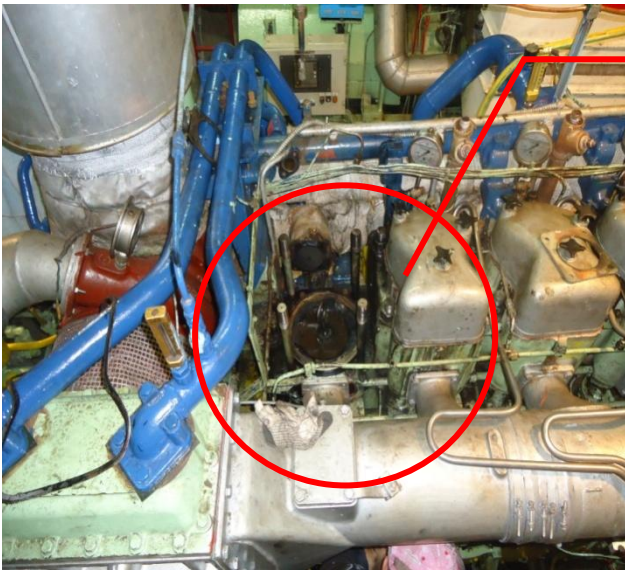
6. The M/E was found out of order. Particularly No.1 cylinder (liner, jacket and piston) was found overhauled (because of a crack at the jacket, without the relevant reporting to the competent Authorities. The deficiency was noted as a clear ground for detention.

No. 1 cylinder overhauled.

The M/E was found out of order as the No.1 cylinder was found overhauled due to a crack on the jacket.

*Although the above malfunction was clearly a damage, it **was not** categorized as "accidental" because the Master **did not** follow the prescribed procedure set on :*

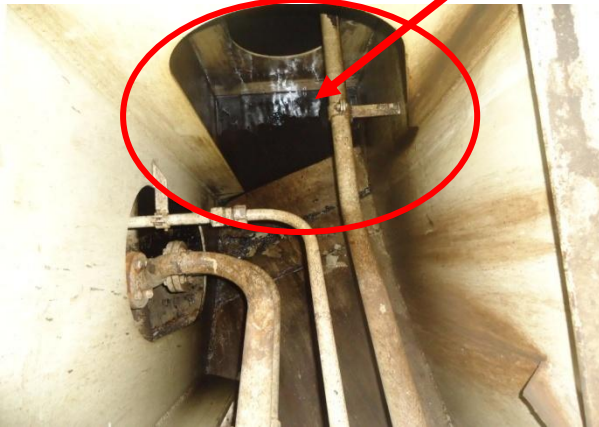
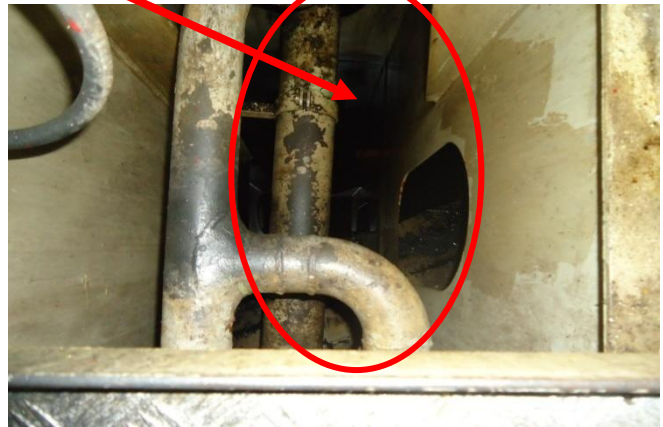
1. Placards were missing from the dedicated garbage storage positions.
2. The bilges were found contaminated with oil residues. The deficiency was notes as a clear ground for detention.
